Play Area Access Audit

New Street Park

Chipping Norton TC

Site name: **New Street Park**
Date of inspection: **05 December 2024**
Inspector: **Mila Yearley**

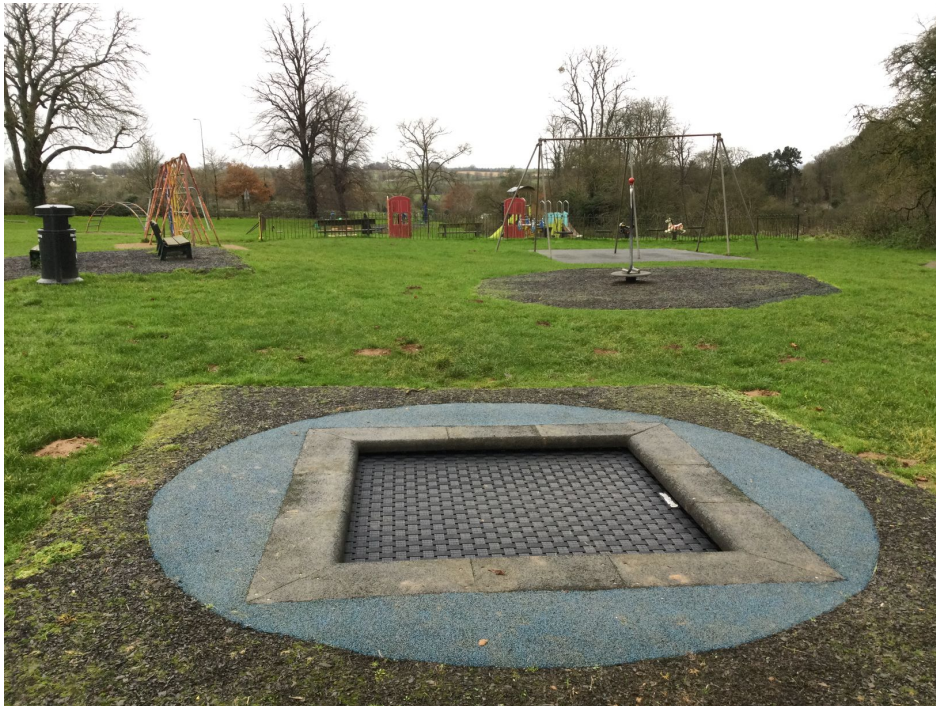
This is a sloped site, it is not deemed possible to make the surface any more level. Some users may struggle with the incline.

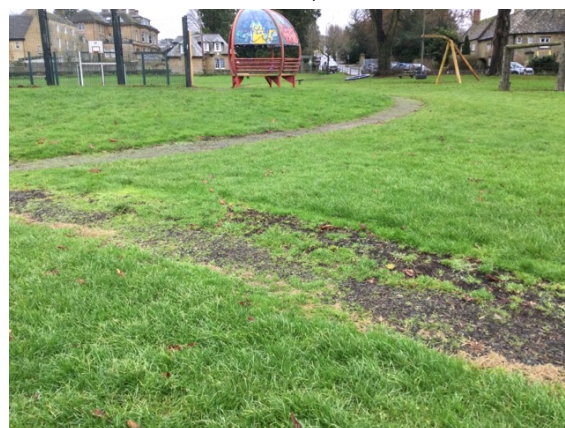
9 Is there a level access from the nearest public access path to and into the play area? **No**

The whole park is on a slope. (This should be provided in accordance with PD CEN/TR 16467:2018, clause 6 BS 8300-1:2018, 8.1, 12.6 Gradients:
< 1:60 is level
> 1:60 < 1:20 is gentle slope (needs landings every 500 mm rise) > 1:20 is a ramp
Cross-fall maximum is 1:50..)

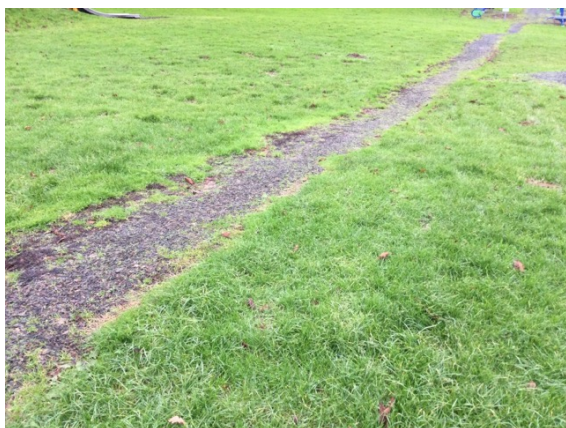
- 17** Is the surface suitable for year-round use? **No - partially accessible**

The surface is grass on a slope. It may be unusable for some disabled users. (This should be provided in accordance with PD CEN/TR 16467:2018, clause 6.) The bonded rubber mulch paths are suitable.

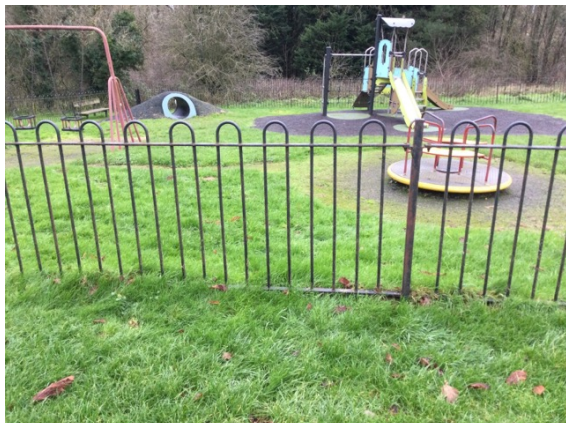
- 29** Crawling
(e.g. tunnel, narrow bridge) **Present but not accessible**

Tunnel accessible only to some as it is at the bottom of the slope.

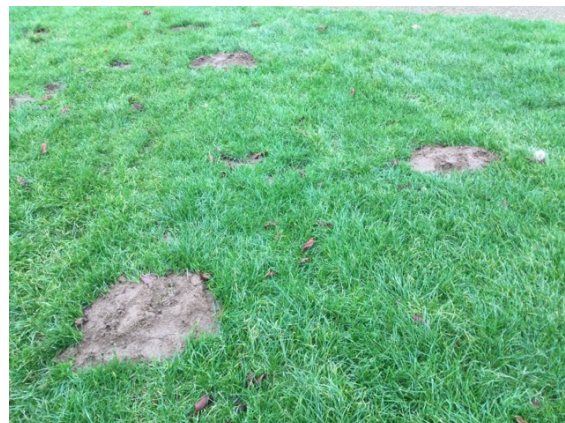
- 38** Tactile
(e.g. water, sand, mud, grass, sound) **Present and accessible**
