Pool Meadow Restoration Project

By Beaumont Rivers Ltd.

On behalf of Chipping Norton Town Council

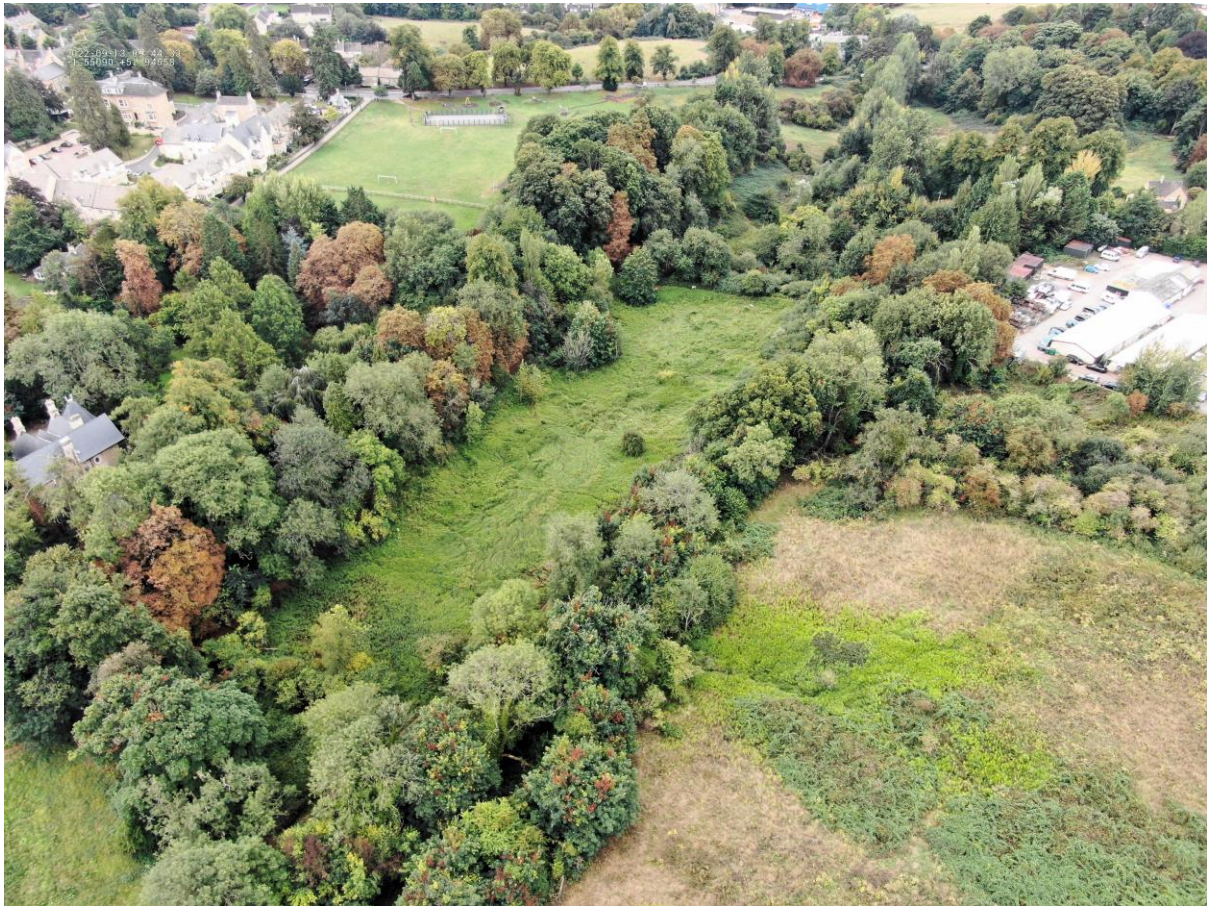
Photograph 1 - Showing Pool Meadow (centre) and its proximity to the town

Pool Meadow is a public open space set within picturesque countryside immediately north of Chipping Norton. The site is an open, roughly rectangular area, measuring approximately 180x65m (see photograph 1). The northwest face of the site is demarcated by a stream, and there is a continuous raised bund along the northwest and southwest perimeters with a popular footpath along the top. The footpath is narrow and in poor condition, and erosion from use has led to significant uneven downward erosion of the bund (see figure 9). At some times of year, this makes it difficult to walk down and it is completely inaccessible to pushchair and wheelchair users.

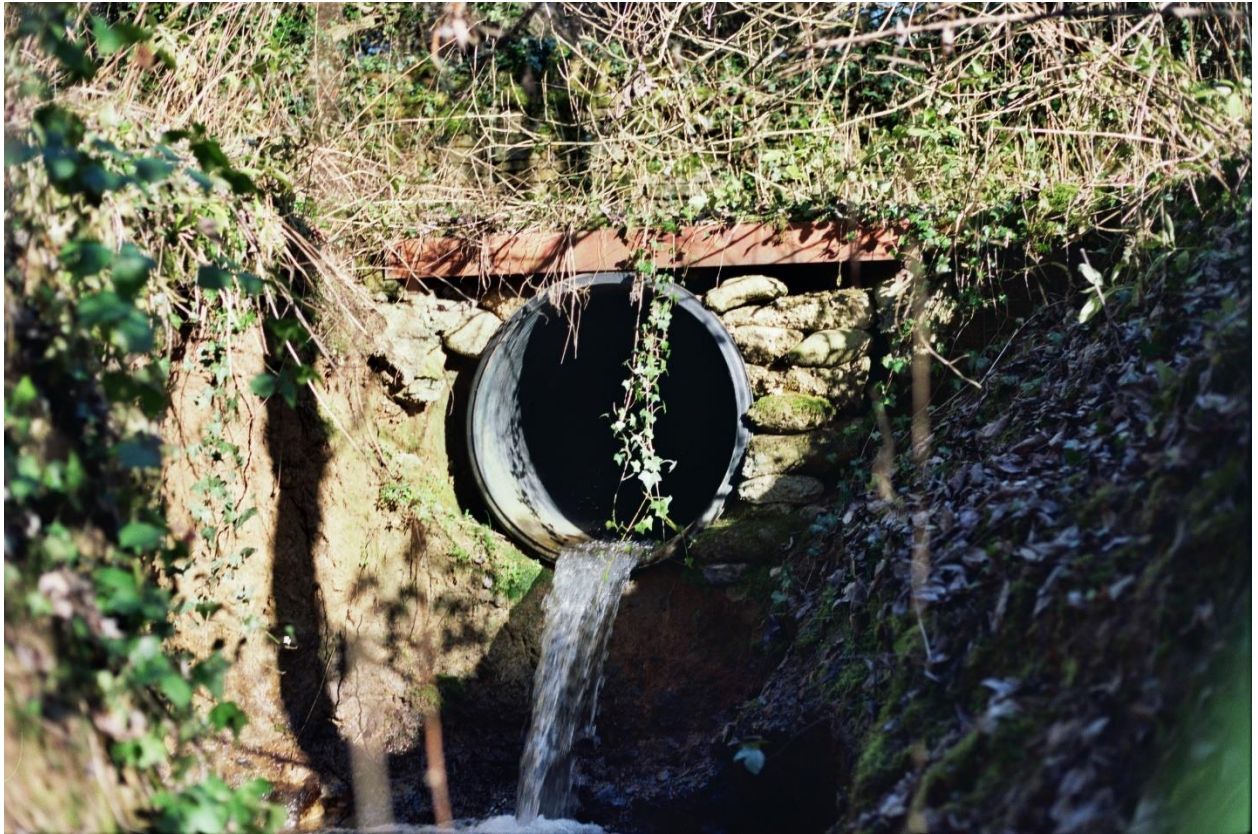
Photograph 2 - Pipe at the upstream end of the meadow (beneath the track from Church Lane)

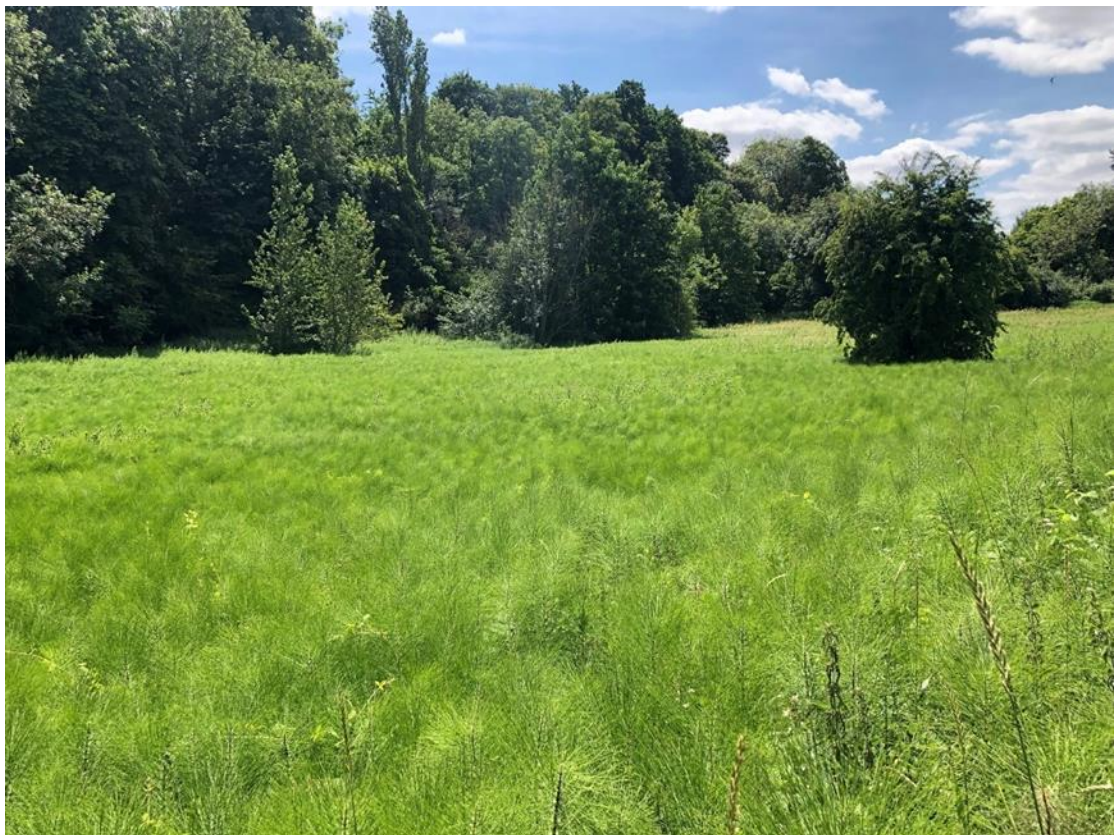
Photograph 3 - Dominant Equisetum (Horsetail) growing in Pool Meadow

Since the pool was drained it has been colonised by Great Horsetail (*Equisetum telmateia* – see photograph 3), which has out-competed almost all other ecology, leading to poor biodiversity within the meadow (Lucas, 2023). This combination of abundant natural resources and amenity potential offers significant opportunity for environmental, biodiversity and amenity improvements to the local area.

As can be seen in photograph 3, at present, the meadow is dominated by Great Horsetail (*Equisetum telmateia*), which has out-competed almost all other ecology, leading to poor biodiversity within the meadow.

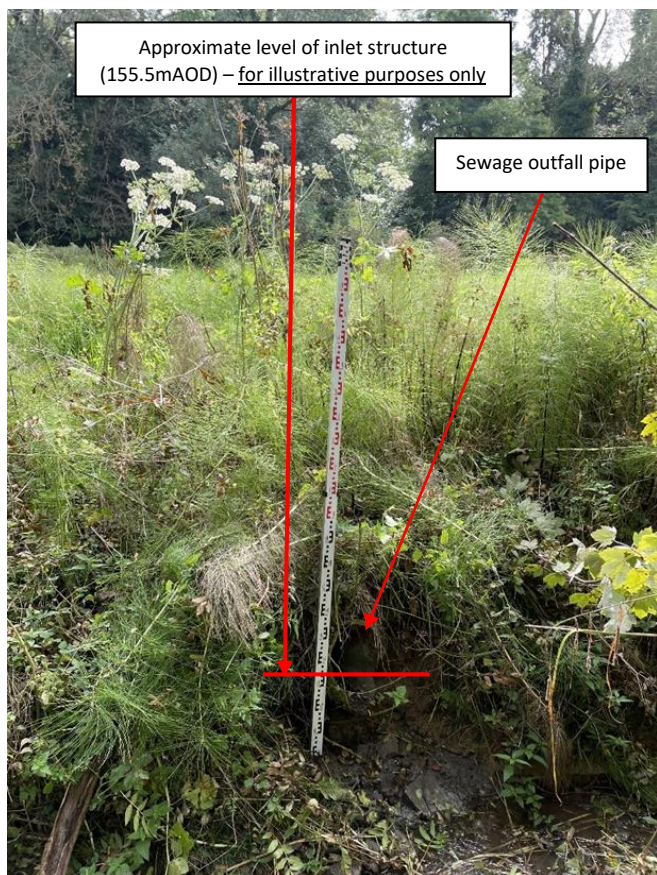
Photograph 6 - Location and indicative level of inlet structure

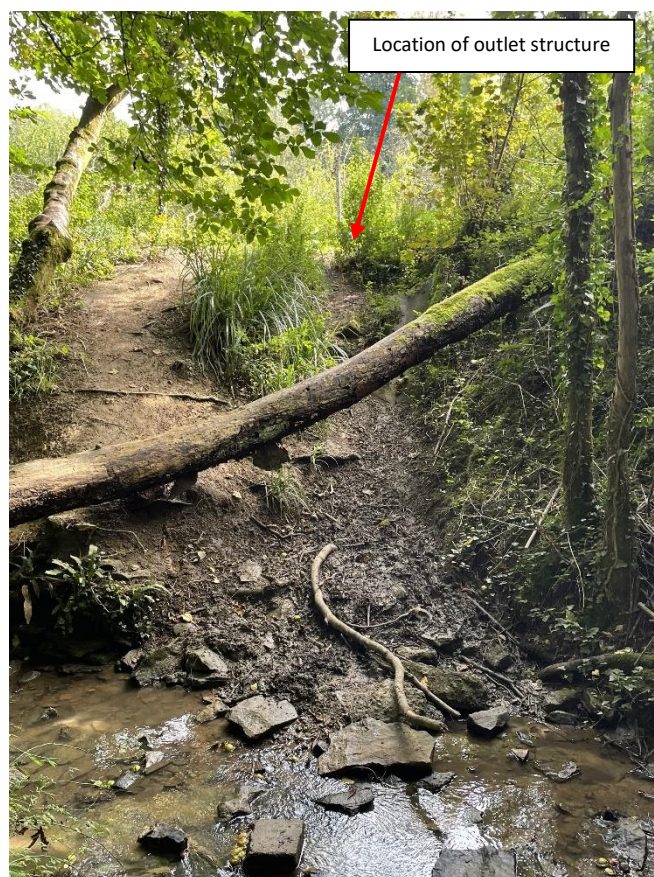
Photograph 8 - location of outlet structure

The downstream control structure has been designed to be slightly higher than the level of the existing bund, so we can construct it by adding material to the historic structure, rather than excavating into it (see photograph 8).

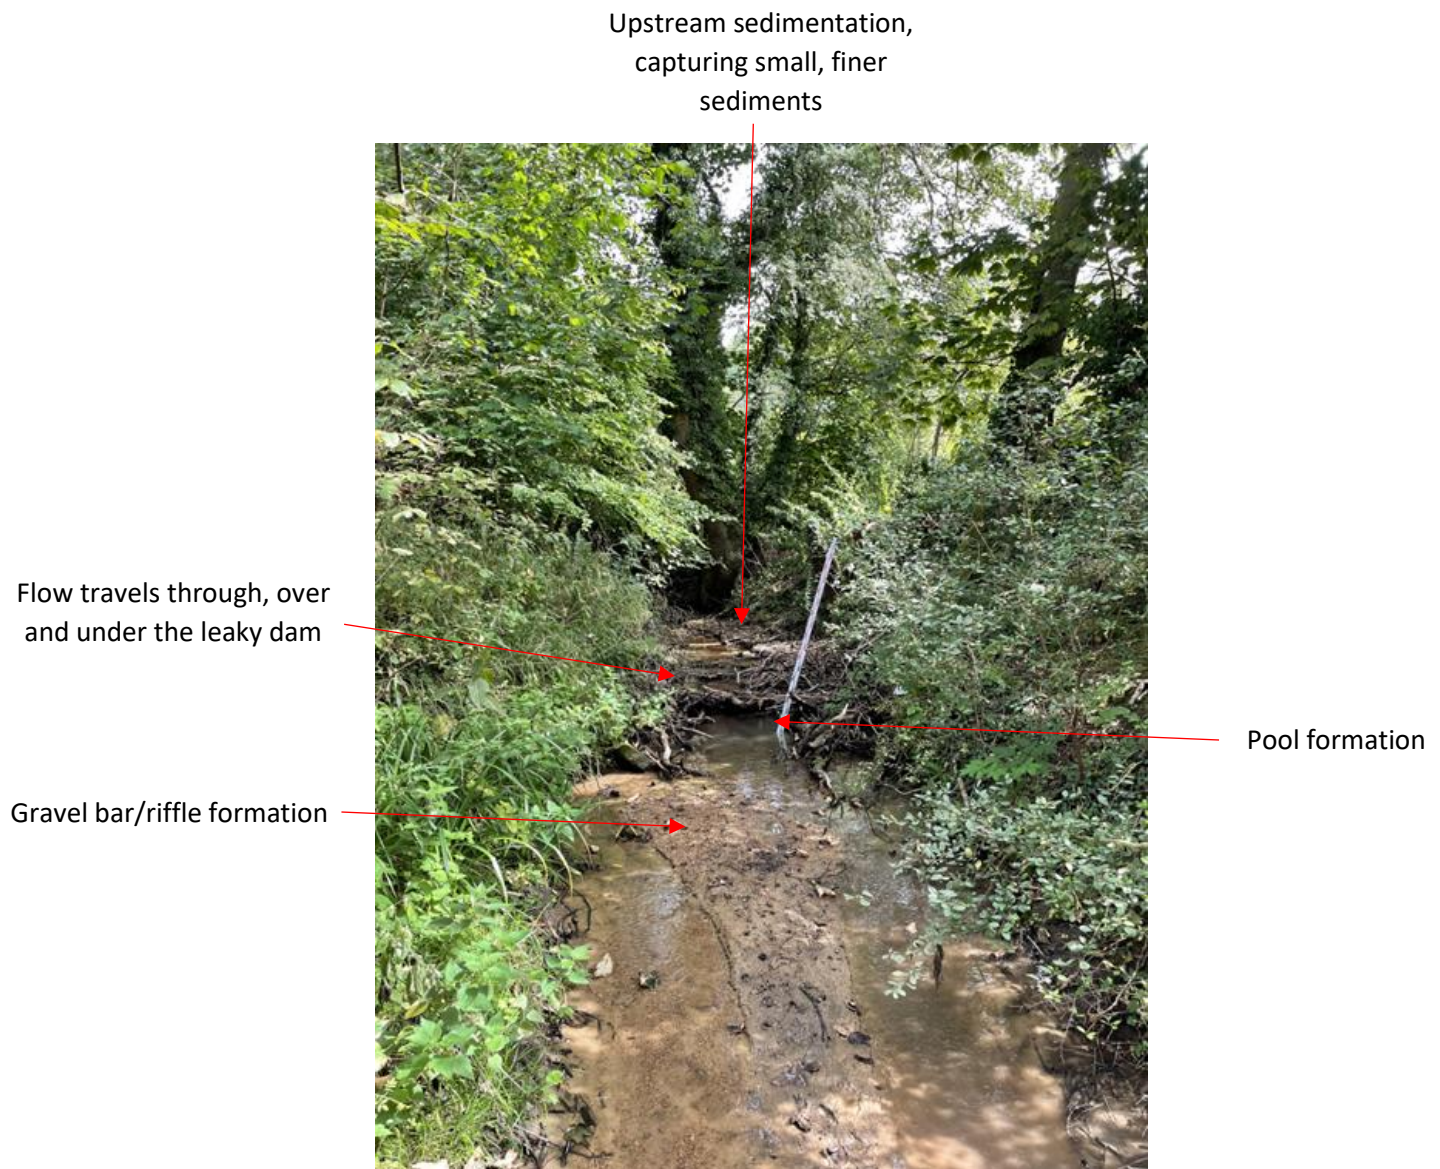
Photograph 9 - Leaky dam on site exhibiting textbook geomorphological impacts

Leaky dams create a natural impoundment of water that slows the flow through the structure. This creates a deeper, wider pool of slow-moving water immediately upstream, which causes sediments to drop out of solution, gradually raising the bed level. Due to the difference in levels between up and down-stream, an area of vertical erosion forms immediately downstream of the structure. The eroded material is then deposited as a bar or riffle immediately downstream (Woodland Trust, 2016). The 3 pre-existing leaky dams appear to be naturally formed and have produced the exact geomorphological changes that we would hope to see from a successful installation (see figure 4 and photograph 9).

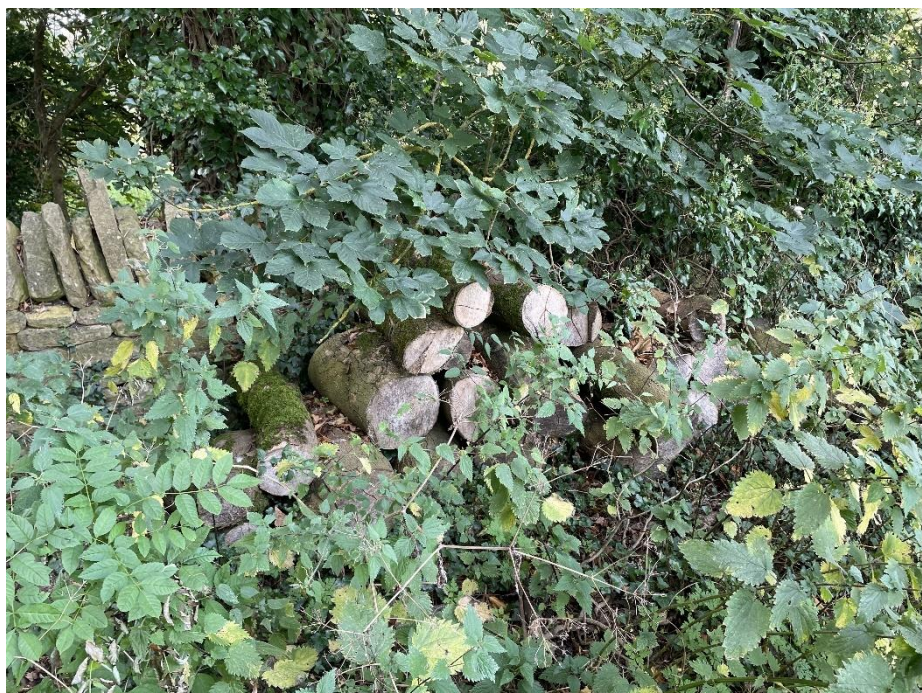
Photograph 12 - One of several existing habitat stacks on site

Habitat stacks are piles of dead wood that provide habitat and refuge for mosses, lichens, fungi, insects, small mammals and amphibians. There are already a number of habitat stacks of varying sizes with an excellent range of material that are benefitting the local environment on site (see photograph 12), and a total of 3 additional habitat stacks are planned; 2 in the wildflower meadow, and one slightly within the wetted margin of the pool. Timber will be sourced from the felling and maintenance of the hawthorn and blackthorn scrub near the bund at the downstream end of the site, and from any local tree works. This will provide a range of timbers of different sizes and species in wet, dry, sunny and shady locations, to allow a biodiverse population of inhabitants.

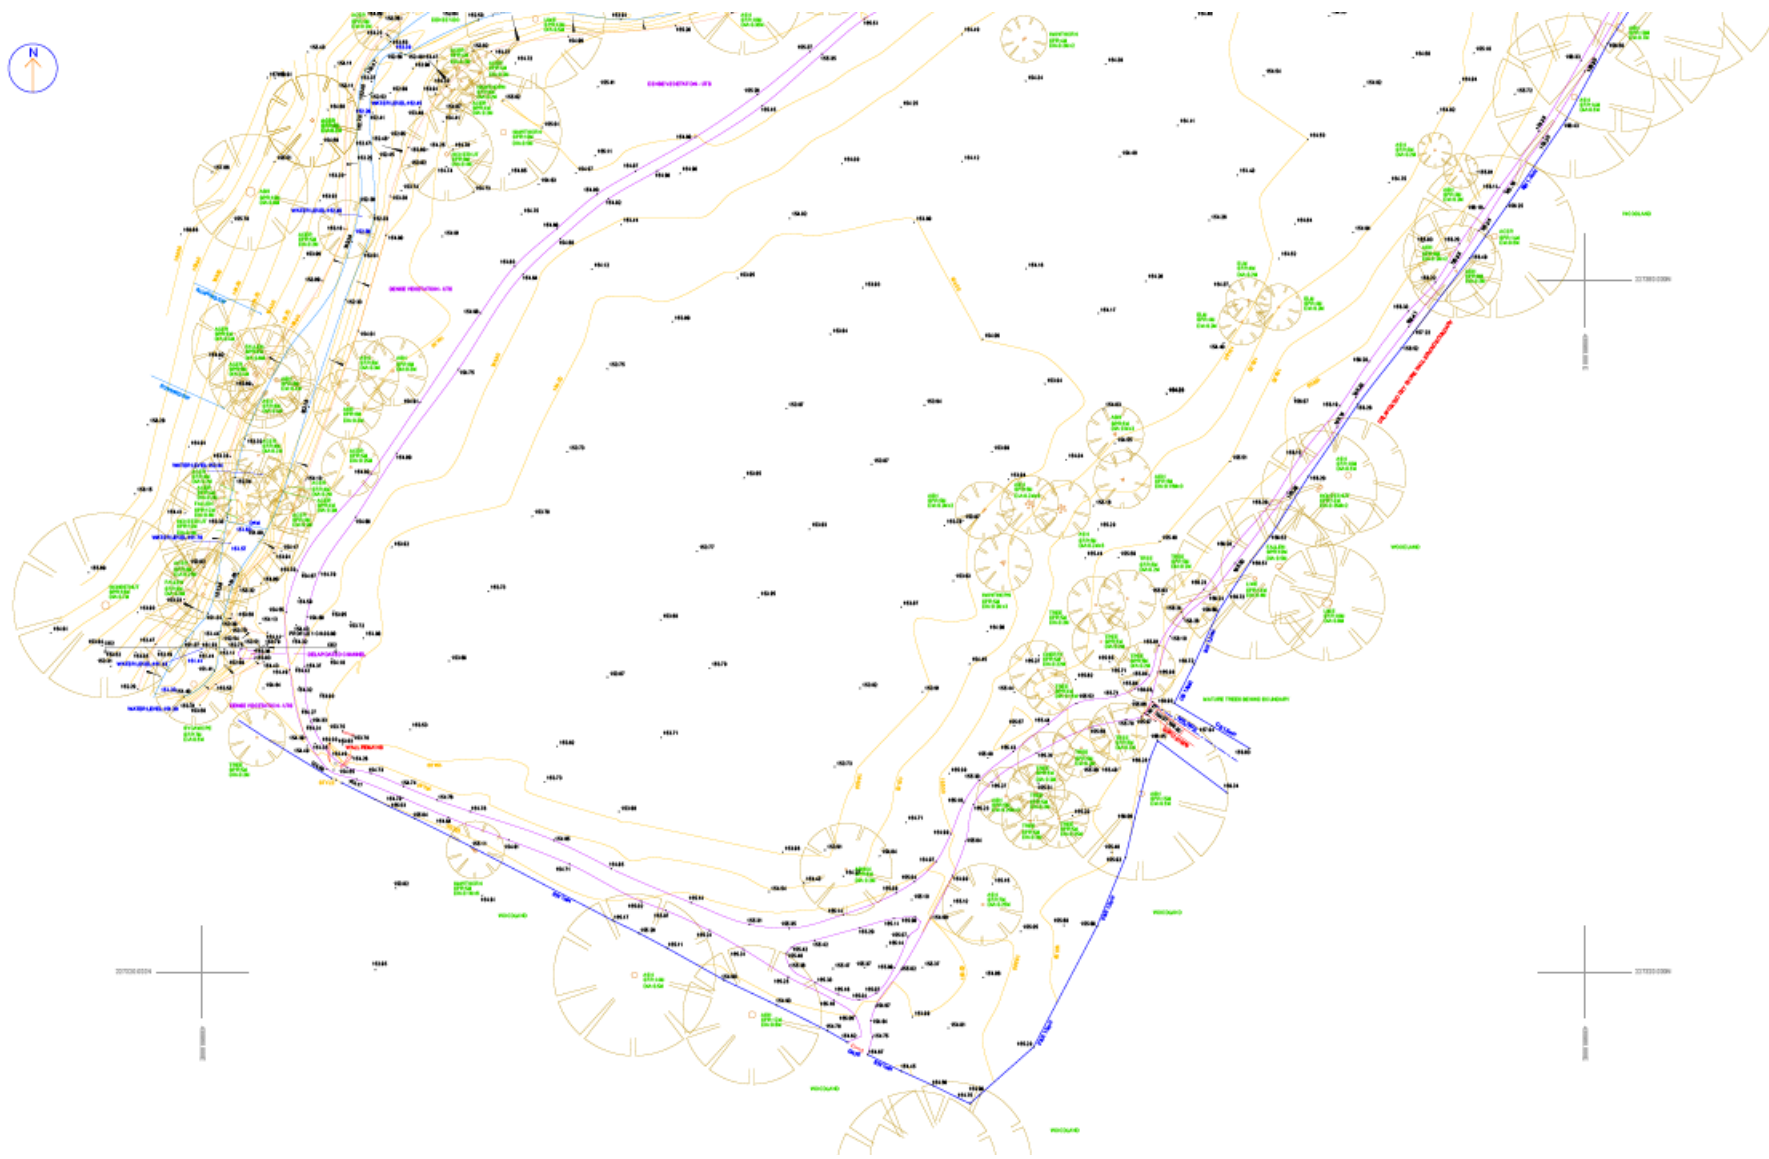
Figure 8 - Topographical survey of downstream end of Pool Meadow (taken from Oxford Geospatial, 2023)

Results from the survey can be seen for illustrative purposes below, with the full survey data included with this report.

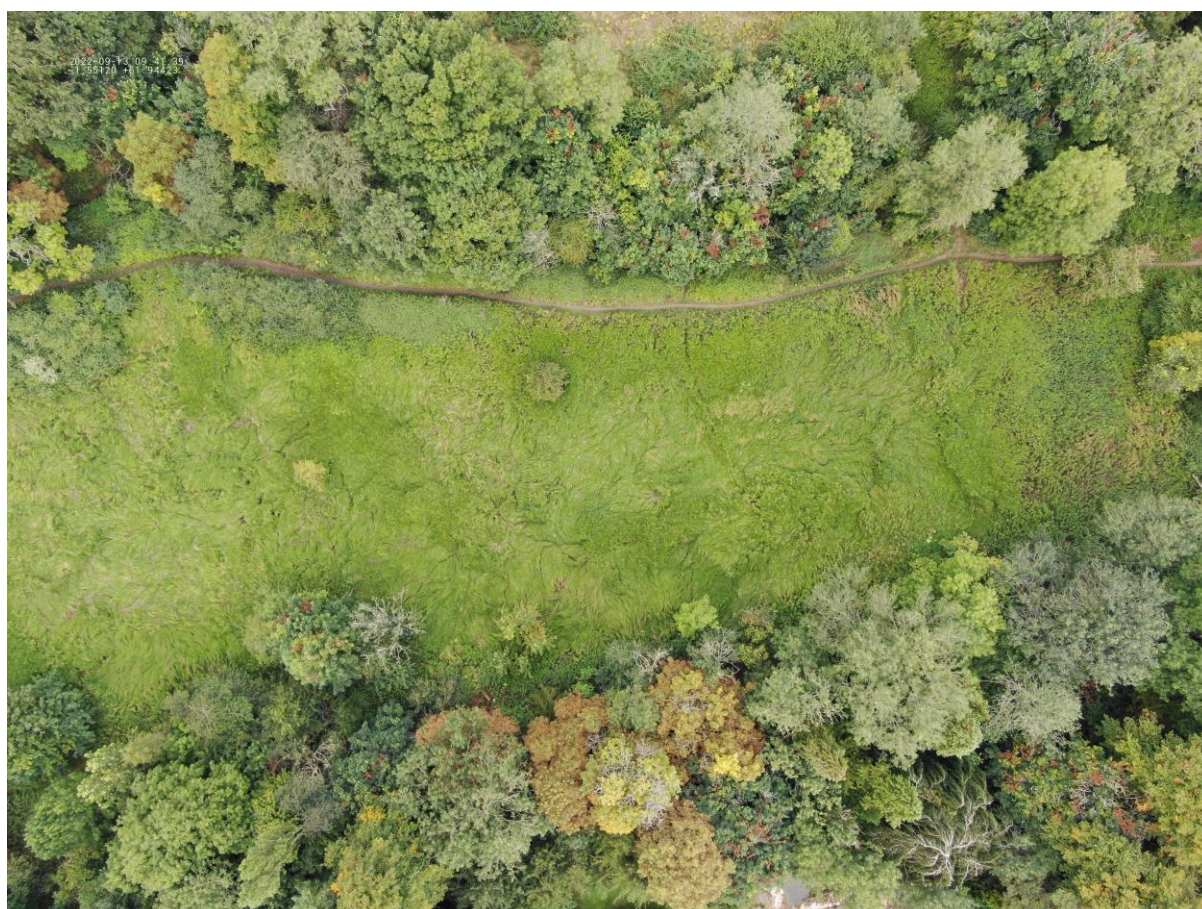
Photograph 14 - Drone imagery showing the narrow footpath and progressive encroachment of trees onto the archaeological site

The heritage and archaeology of the area is under threat by the encroachment of trees (see photograph 14) and footpath erosion along the top of the bund by frequent traffic (see figure 9). By improving the surface of the footpath and maintaining the pond and wildflower meadow proposed, we will stop the degradation of the archaeology and protect the site for generations to come.

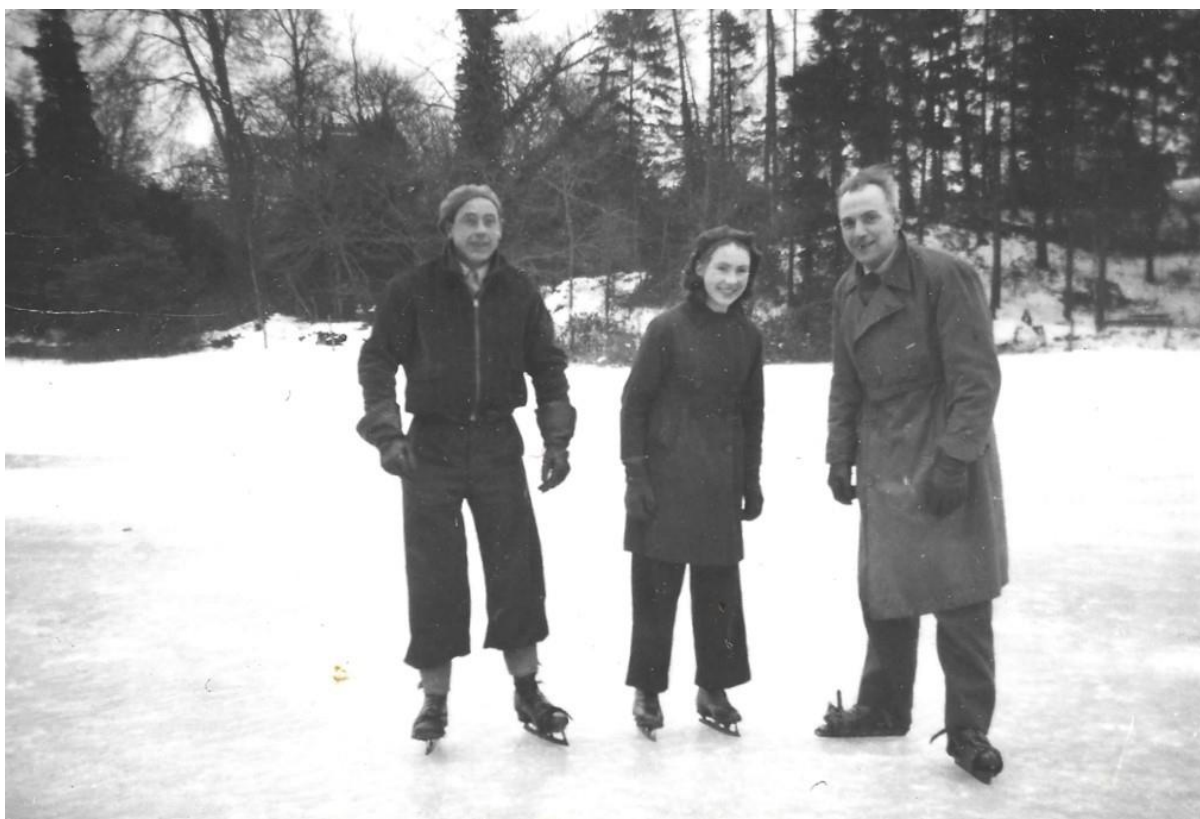
Photograph 15 - Ice skating in Pool Meadow during the mid-late 1940's – see either the Church or Mount in background

As the embankment was impounding in the photograph, it can be safely assumed that it was maintained in accordance with reservoir safety legislation at the time. This further strengthens the theory that it is a comparatively modern (Georgian/Victorian) structure, as a medieval structure would be unlikely to be constructed to design specifications capable of holding that volume of water for hundreds of years without significant, expensive work.
