Pool Meadow Restoration Project

By Beaumont Rivers Ltd.

On behalf of Chipping Norton Town Council

Beaumont Rivers Ltd. has been commissioned by Chipping Norton Town Council to investigate the feasibility of restoring the area within Pool Meadow to a ponded wetland area with improved amenity benefits. We have found that the project is eminently feasible and offers numerous benefits to ecology, flood risk, geomorphology, archaeology, community amenity, local prosperity and education.

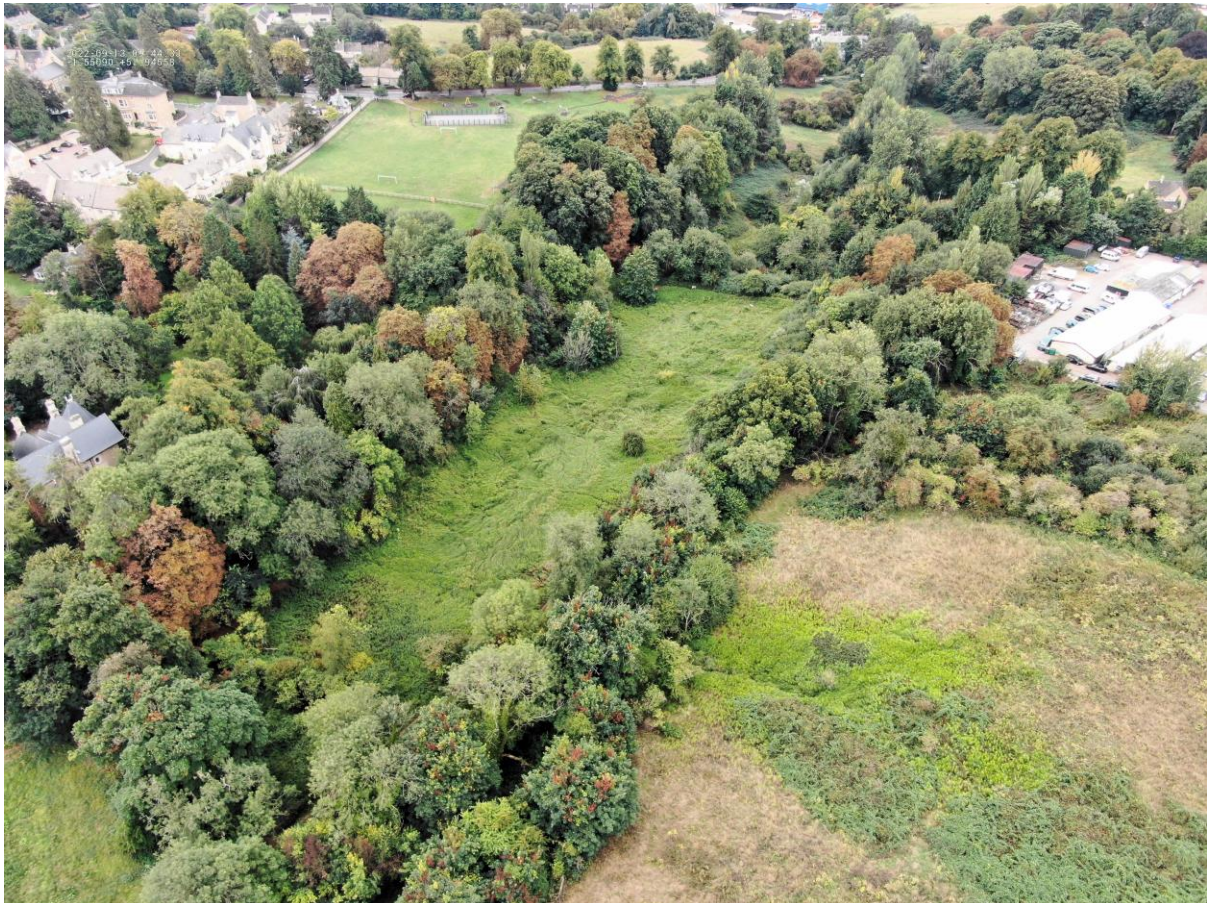
Photograph 1 - Showing Pool Meadow (centre) and its proximity to the town

Pool Meadow is a public open space set within picturesque countryside immediately north of Chipping Norton. The site is an open, roughly rectangular area, measuring approximately 180x65m (see photograph 1). The northwest face of the site is demarcated by a stream, and there is a continuous raised bund along the northwest and southwest perimeters with a popular footpath along the top. The footpath is narrow and in poor condition, and erosion from use has led to significant uneven downward erosion of the bund (see figure 9). At some times of year, this makes it difficult to walk down and it is completely inaccessible to pushchair and wheelchair users.

Despite the meadow being part of a natural floodplain, the bund separates the area from the surrounding hydrology, resulting in a disconnect between the stream and flood plain. Ground level on the northeast and southeast faces rises naturally to higher ground in the direction of the centre of Chipping Norton, forming a gentle bowl within the meadow (see photograph 1 and Topographical Survey section).

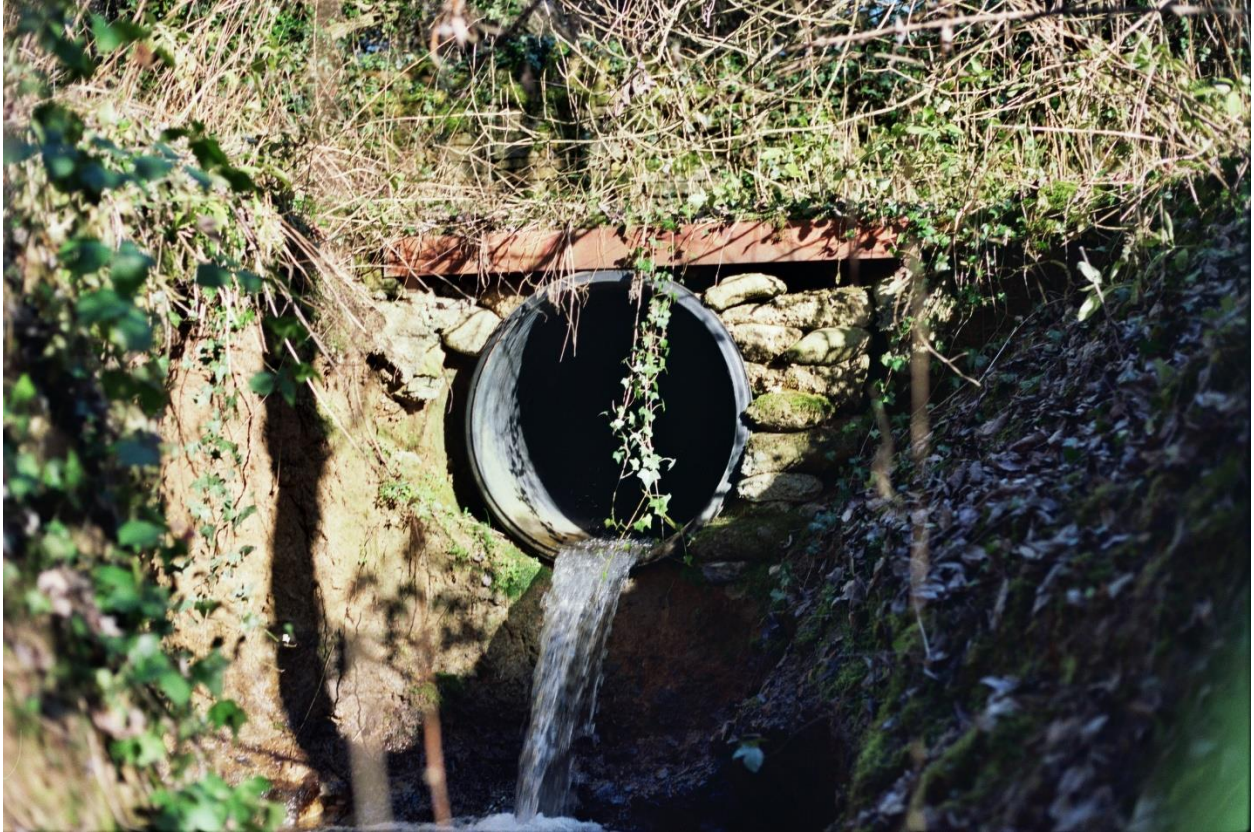
Photograph 2 - Pipe at the upstream end of the meadow (beneath the track from Church Lane)

The stream is a relatively small watercourse rising near Over Norton, and flowing through an area of mixed agricultural use before entering into the study area via a 90cm plastic pipe (see photograph 2), set approximately 70cm above the subsequent water level (tail level depends on flow rates). The stream flows the length of Pool Meadow, losing 5.3m of elevation while being joined by numerous minor gullies and tributaries from the farmland to the northeast (Oxford Geospatial, 2023) that significantly increase flow between the extents of the reach. The gully that joins the watercourse immediately upstream of the impoundment structure approximately doubles the flow during summer months, and significantly increases flows in winter (see photograph 5). Despite historic anthropogenic interventions, the stream exhibits some geomorphologically diverse features, including meanders, 3 natural large woody debris dams, pool and riffle formations, mid-channel and point bars, and a diverse range of sediment sizes (see survey mapping in figures 7 and 8 and photograph 9). The banks of the stream are vegetated with mixed deciduous woodland, some reeds, nettles, grasses, and other riparian vegetation, but there is a lack of submerged species and only a small amount of brooklime as emergent vegetation (Lucas, 2023).

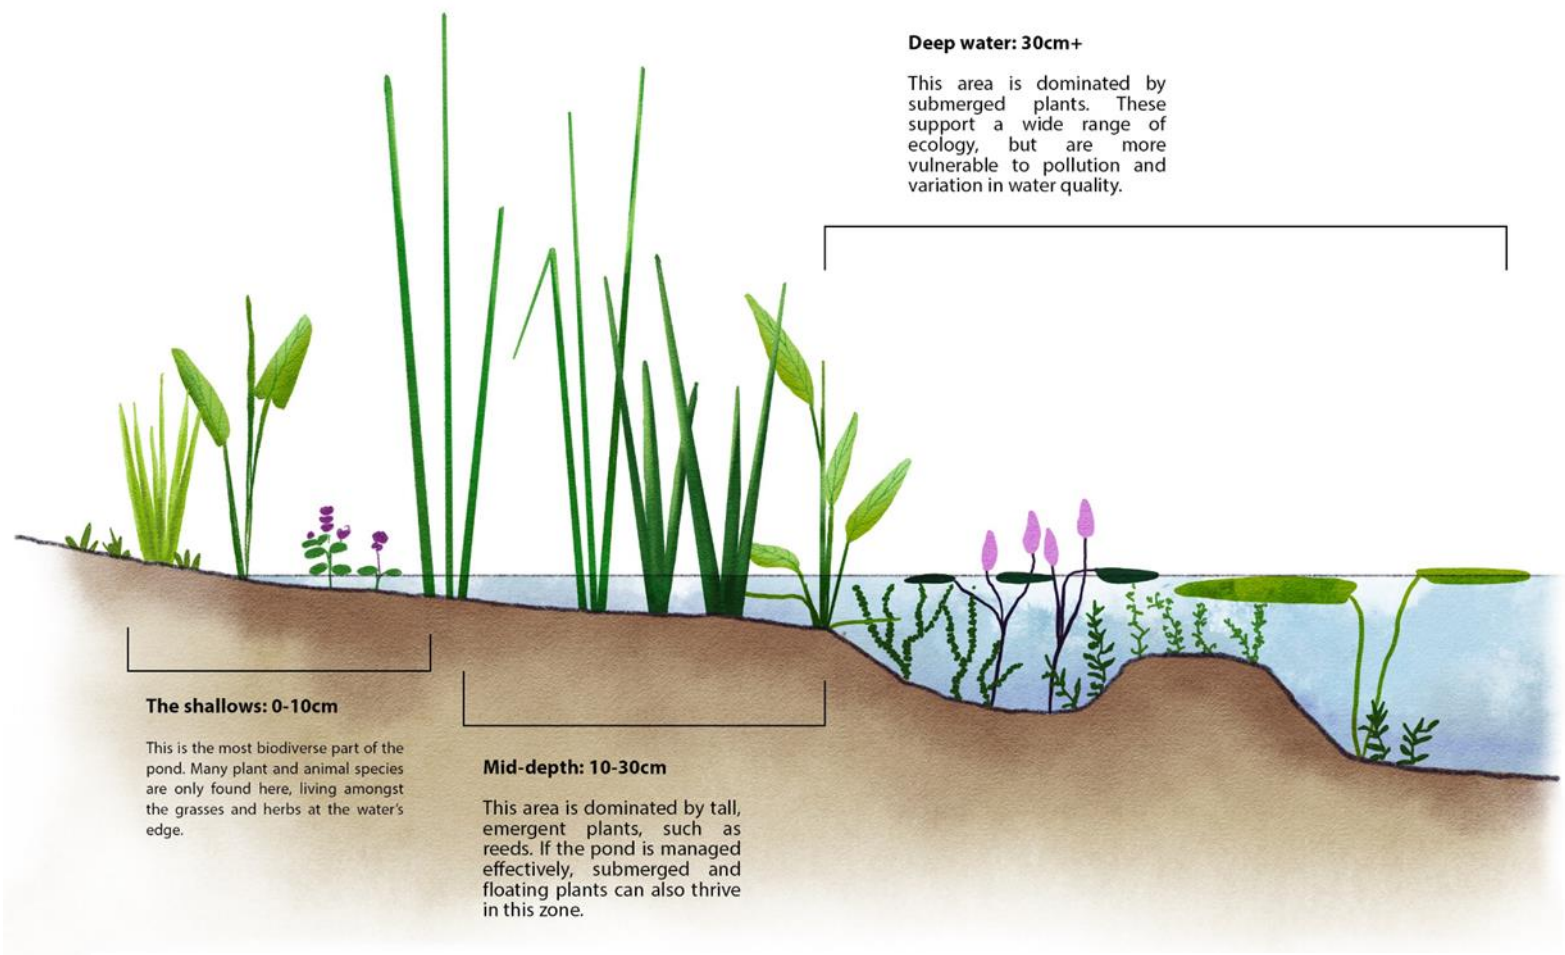
Figure 1 - Ecological zones of a pond

Figure 1, below shows the different ecological zones that will be created and the sort of ecology that we can expect to see in them.

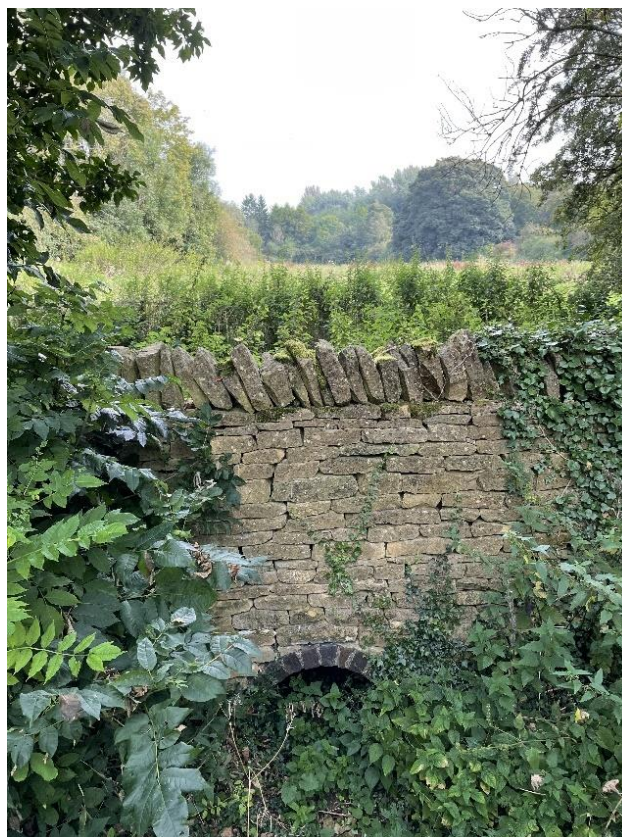
Photograph 4 - Partially collapsed culvert under the track, with upstream meadow in the background

The culvert under the track is partially collapsed and although a small volume of water flows through it after rainfall, it would need restoring to avoid blockage and asset failure. Current flow through the culvert is dissipated into the infilled area at the top of the meadow, so a channel would need to be created to direct the water into the desired part of the meadow.

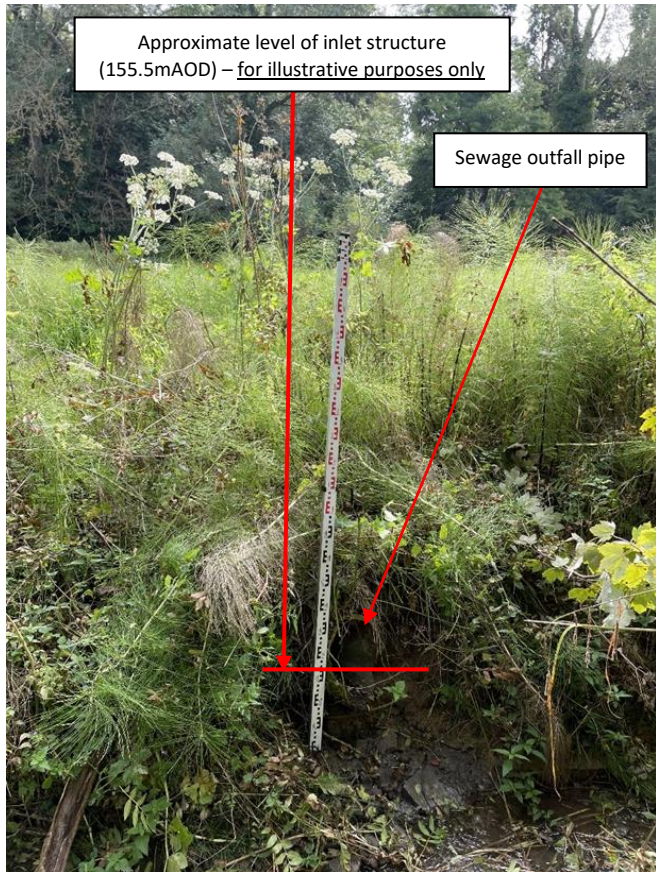
Photograph 6 - Location and indicative level of inlet structure

The outfall into the stream has an invert level of 155.46mAOD, so will need to be removed for the extent of the new channel, which will be dug to 155.5mAOD (see photograph 6). This has the benefit of allowing us to excavate an area of bank without causing further damage to the historic structure; as that section was already excavated and backfilled during the original installation of the pipe.

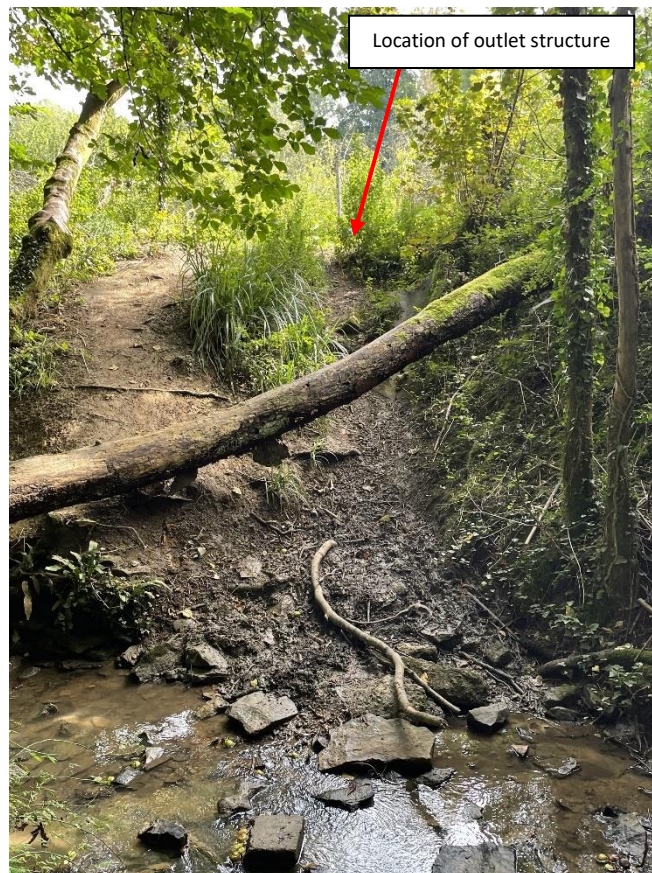
Photograph 8 - location of outlet structure

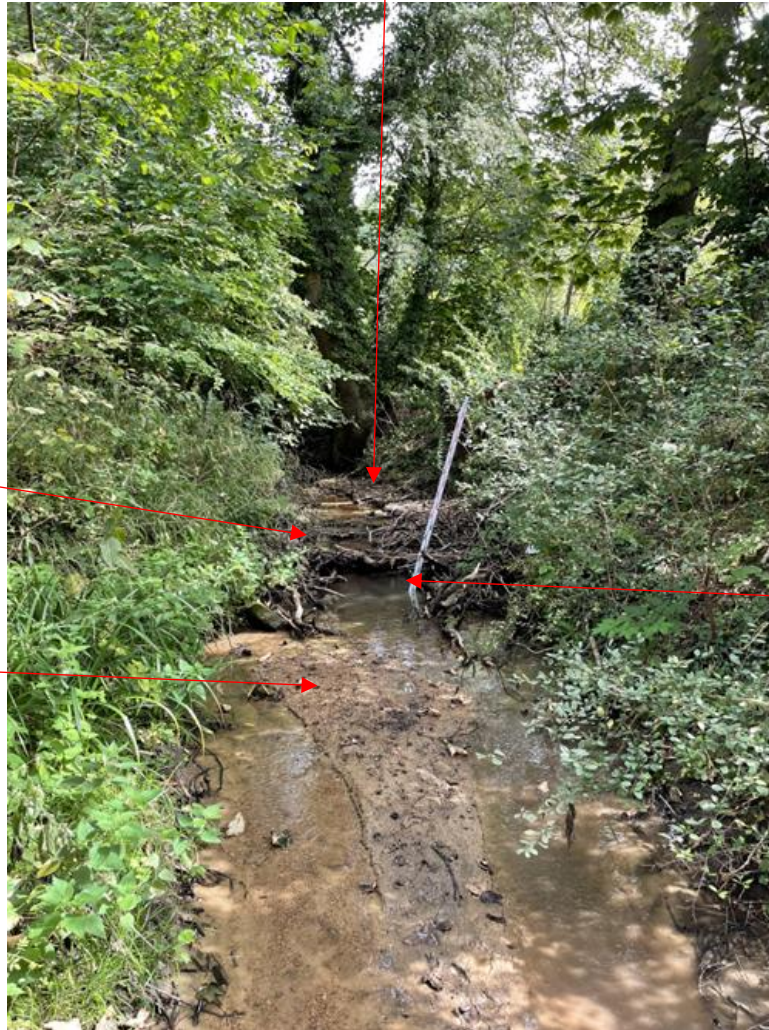
Flow travels through, over
and under the leaky dam

Pool formation

Photograph 9 - Leaky dam on site exhibiting textbook geomorphological impacts

Leaky dams create a natural impoundment of water that slows the flow through the structure. This creates a deeper, wider pool of slow-moving water immediately upstream, which causes sediments to drop out of solution, gradually raising the bed level. Due to the difference in levels between up and down-stream, an area of vertical erosion forms immediately downstream of the structure. The eroded material is then deposited as a bar or riffle immediately downstream (Woodland Trust, 2016). The 3 pre-existing leaky dams appear to be naturally formed and have produced the exact geomorphological changes that we would hope to see from a successful installation (see figure 4 and photograph 9).

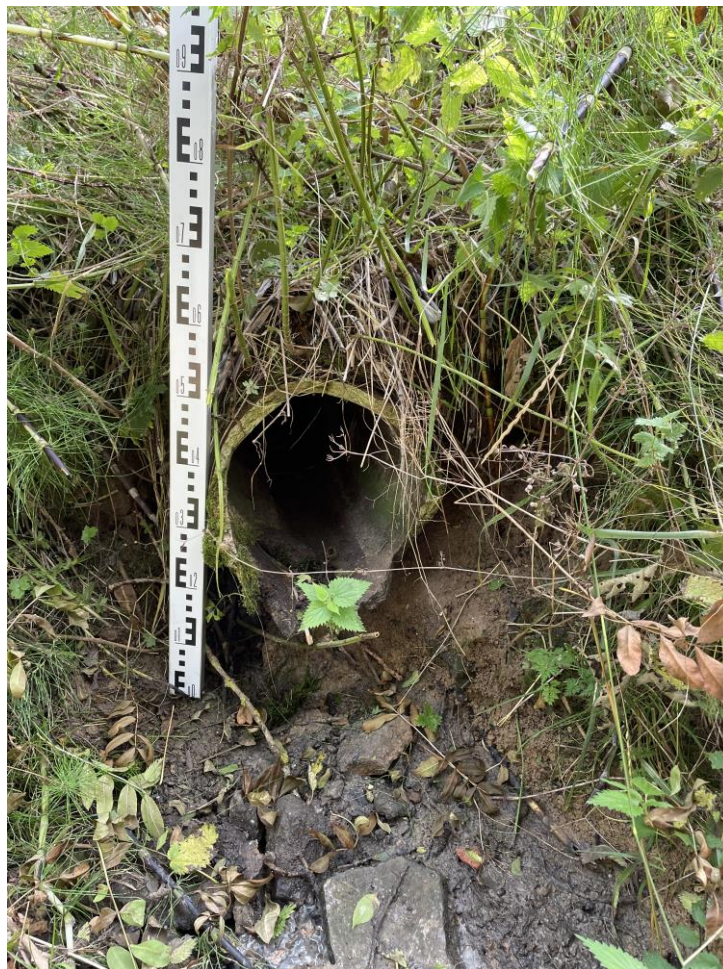
Photograph 10 - Combined sewage outfall at Pool Meadow

There is a combined sewage overflow within the reach (see photograph 10) that discharges after periods of high rainfall when the local waste water network reaches a certain capacity. Any sewage pollution has significant impacts on the chemistry and ecology of a watercourse, and its installation across the Scheduled Ancient Monument will have caused significant damage to the industrial and archaeological value of the area.

The location for the intake was chosen based on existing geomorphology and minimising the impact on the Scheduled Ancient Monument. There is currently an unrecorded (by Thames Water) combined sewage overflow (see photograph 10) that discharges after periods of high rainfall when the local waste water network reaches a certain capacity. Any sewage pollution at all will be having a significant impact on a watercourse of this size, and it would be severely detrimental to the ecological and chemical status of the future pond. It also presents health and hygiene risks for people and their pets enjoying the amenity of the site.

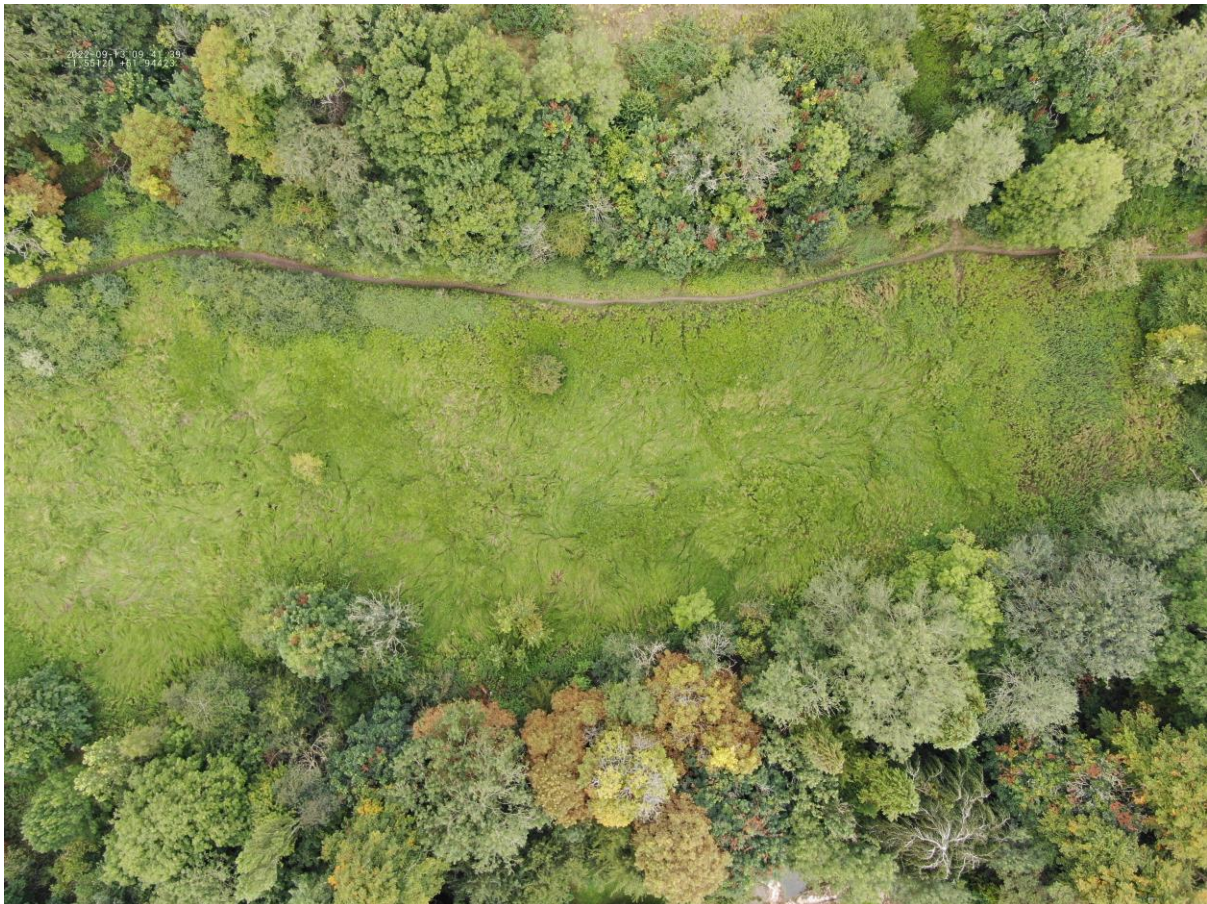
Photograph 14 - Drone imagery showing the narrow footpath and progressive encroachment of trees onto the archaeological site

The heritage and archaeology of the area is under threat by the encroachment of trees (see photograph 14) and footpath erosion along the top of the bund by frequent traffic (see figure 9). By improving the surface of the footpath and maintaining the pond and wildflower meadow proposed, we will stop the degradation of the archaeology and protect the site for generations to come.

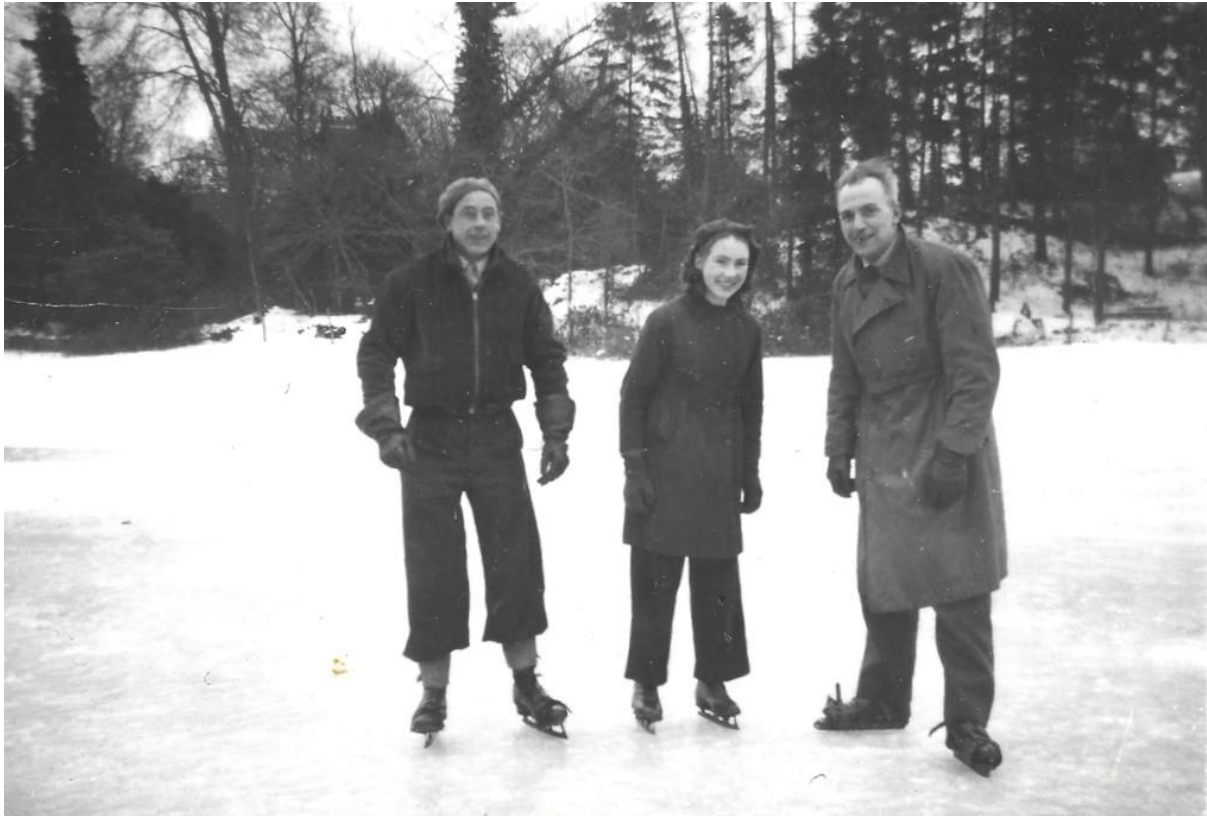
Photograph 15 - Ice skating in Pool Meadow during the mid-late 1940's – see either the Church or Mount in background

As the embankment was impounding in the photograph, it can be safely assumed that it was maintained in accordance with reservoir safety legislation at the time. This further strengthens the theory that it is a comparatively modern (Georgian/Victorian) structure, as a medieval structure would be unlikely to be constructed to design specifications capable of holding that volume of water for hundreds of years without significant, expensive work.

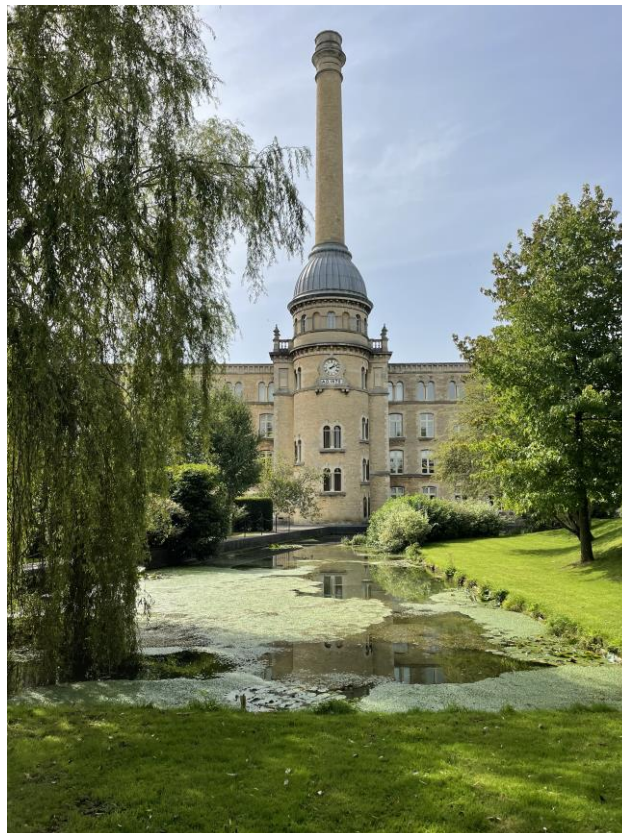
Photograph 16 - Bliss Mill

The watercourse supplies Bliss Mill with water that is now used for aesthetic purposes around the Mill (see photograph 16). Having spoken with the Property Manager, they are happy for flow to be reduced while the pond and wetlands are inundated, so long as they are able to offset the leakage through their sluices with the baseline flow. A loss of head level on site would be unsightly and could possibly risk bank stability on site, depending on the unknown condition of the mill pond pilings.
